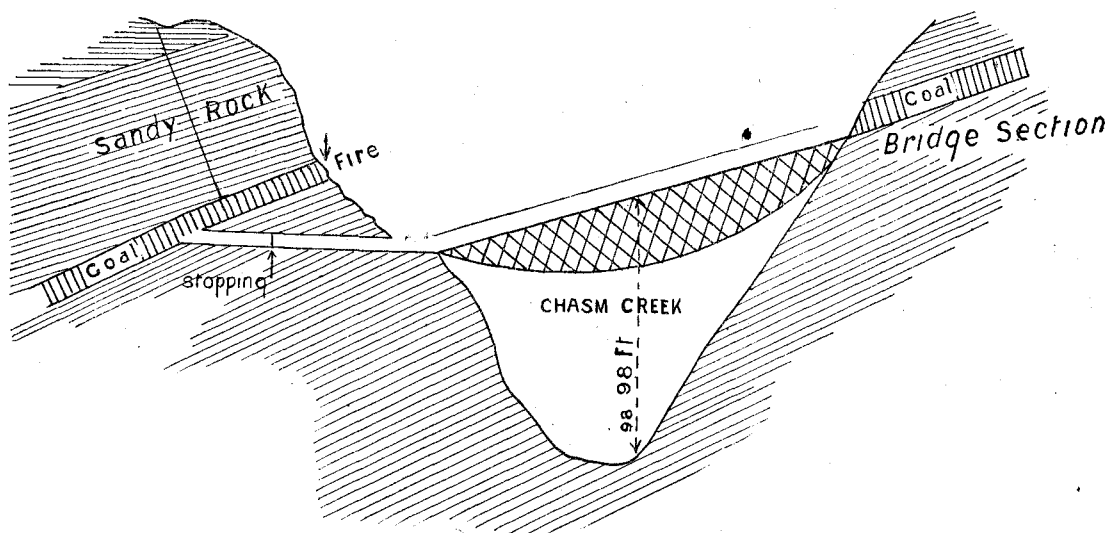
At the time the accumulated water was overflowing at the subsidence referred to, I estimate that all the underground area, tinged blue on tracing, would be under water. (The average of three readings of aneroid gives 58 ft. of rise between stoppings at 1 and 2.) The accumulation of water over this area must have forced the black-damp on to the fire, and I am strongly of opinion that active fire only exists at the present time adjacent to the outcrop, where it can get the necessary fresh air for its support. I am led to this opinion by the fact that some distance back from the cliffs black-damp can be found in cracks to the surface, also that although there is fairly active fire above the tunnel at 2 the stopping there was quite cool when I examined it. (See sketch.)

Near 3 on tracing, the fire at outcrop is very fierce; it is at an elevation beyond the effective power of available water.

So far as operations at the mine are concerned, the present position is as follows: The question of putting in a dam at or near 4 on tracing, and another at top stopping (2 on tracing), which would enable the mine to be flooded practically to the outcrop, appears to have been considered by Messrs. Dixon, Tennent, and Mitchell practically from the first; the difficulty was, how to get to the site for dam at 4, seeing that so large a body of black-damp has accumulated. Owing to its specific gravity (one and a half times heavier than air) it stands to reason that when it can be got at surface cracks back from the burning outcrop, every bit of open ground in the mine must be full of it, and no better fire-extinguisher can be obtained.
