1938.
NEW ZEALAND.

DERAILMENT OF SPECIAL EXCURSION TRAIN NEAR RATANA ON 26th MARCH, 1938.

(REPORT OF BOARD OF INQUIRY.)

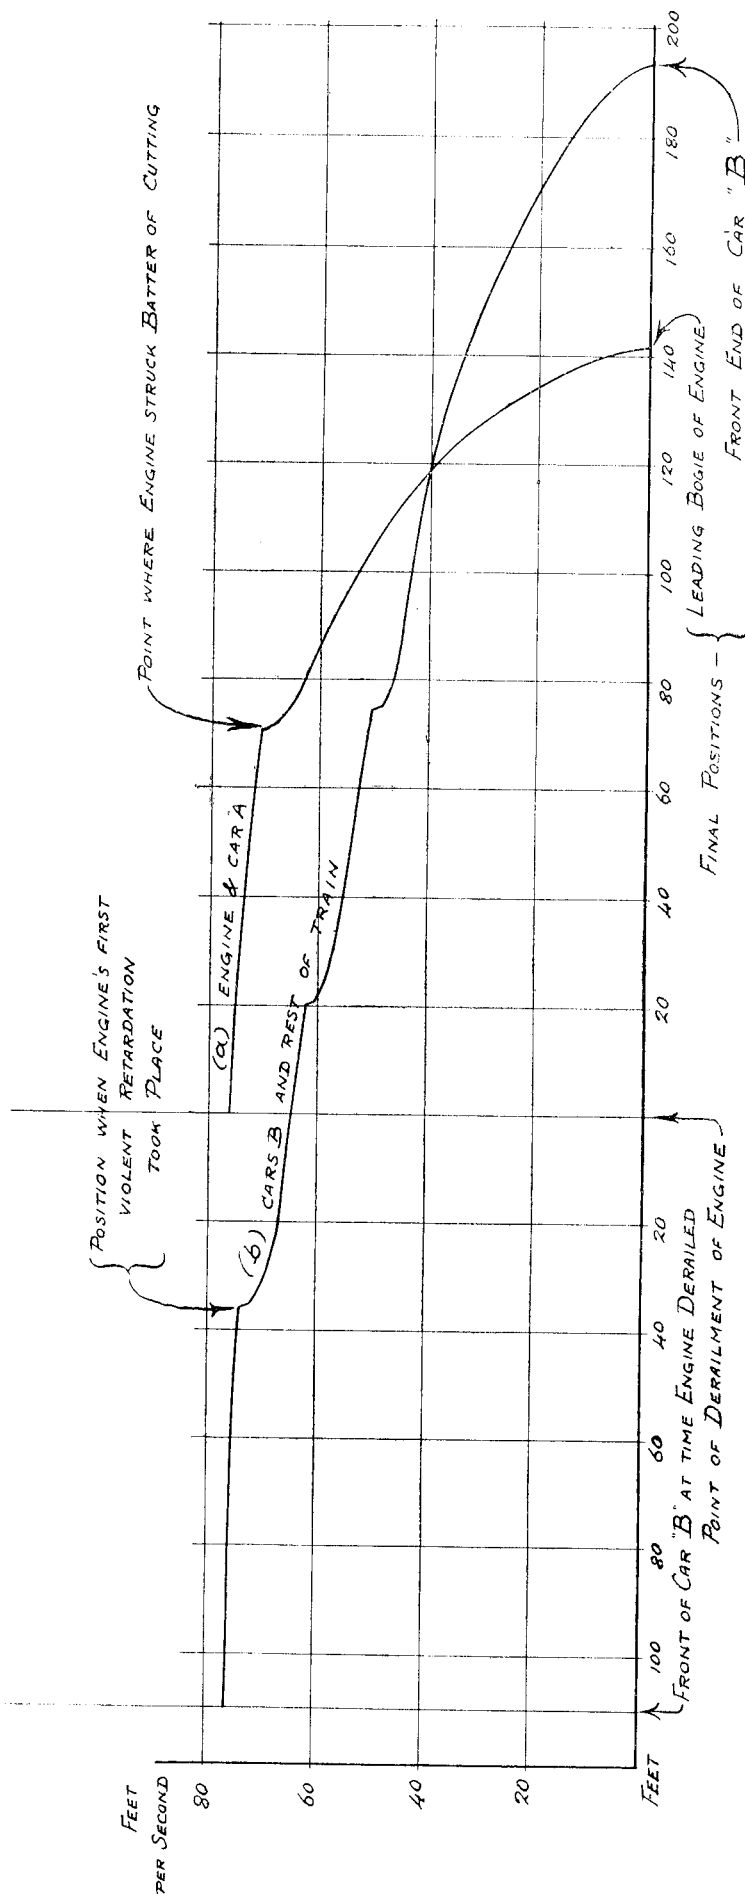
PROBABLE RETARDATIONS
(a) OF DERAILED ENGINE AND (b) OF FOLLOWING CARS

Without attempting to assess the actual values of the retarding forces, to which we have referred, we are satisfied that there are good grounds for the view that the approximation adopted by Professor Scott was, indeed, very conservative; that higher values would be appropriate in the present case; and that the observed results of the accident to train W 4 are compatible with an initial speed possibly more, but certainly not less, than about 50 miles per hour. Professor Scott's values were worked out for submission to a Board of Inquiry that investigated a derailment that took place at Opapa in 1925. At Opapa, under conditions extraordinarily similar to those found at Ratana, the locomotive after derailing travelled 120 ft., as against 142 ft. at Ratana, and the second and succeeding cars travelled 255 ft., as against 304 ft. at Ratana.

The fact that at Opapa there was a total of nine vehicles running down a steep grade, as against a total of seven vehicles at Ratana running on a level stretch of track, would lead, if equal speeds and conditions otherwise similar are assumed, to the expectation of greater travel at Opapa than at Ratana. As the reverse ratio of travel existed, it seems a reasonable conclusion, though we do not stress it, that the initial speed at Ratana exceeded that at Opapa, which, according to Professor Scott's values, was 50 miles per hour.
